Brief report of the 2016 Kumamoto Earthquake in JAPAN

IAEG Japan National Group (Japan Society of Engineering Geology)

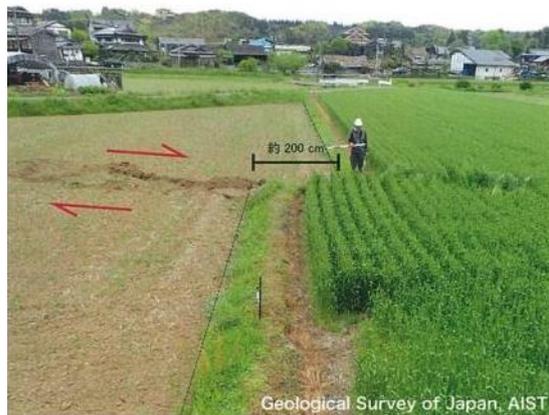
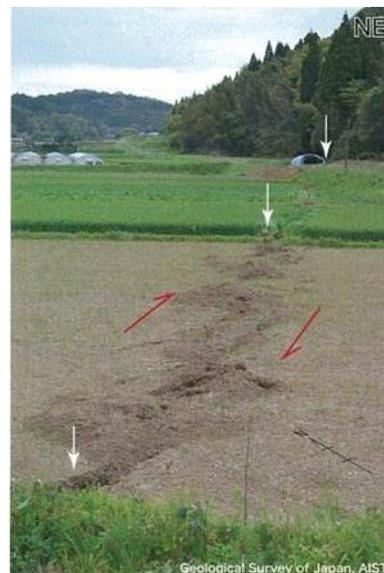
There are two right lateral active faults, Hinagu fault and Futagawa fault near Kumamoto City. According to the analysis of the surface movement by MAI (Multiple Aperture Interferometry), right slip movement along these faults are clearly shown. (Fig.5) And surface faults along Futagawa Fault with right lateral slip displacement of maximum 2 m were observed. (Fig.6)

Fig. 6 Earthquake surface fault along Futagawa Fault.
 → Right lateral slip movement was observed.

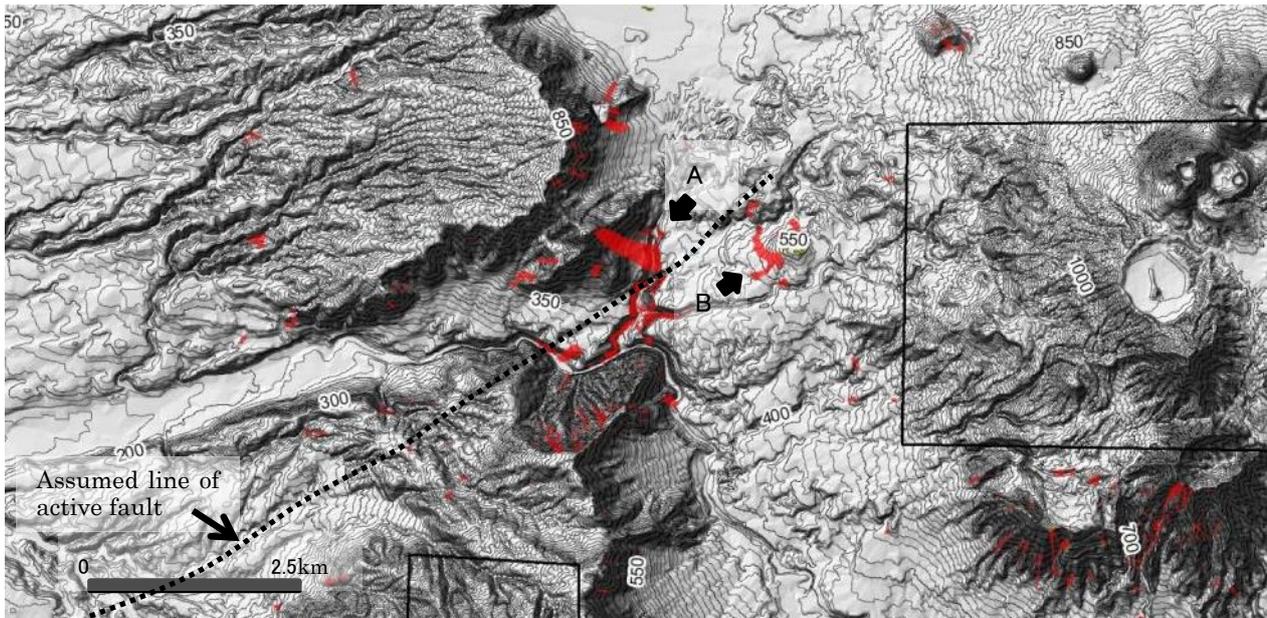
Futagawa fault continues to the northeast area of the somma and atrio of Volcano Aso. Figure 7 shows a preliminary report of the distribution of landslides and collapses in this area.

Fig.7 Preliminary analysis of landslides distribution and collapses in the west area of Volcano Aso (Assumed fault line is added.)

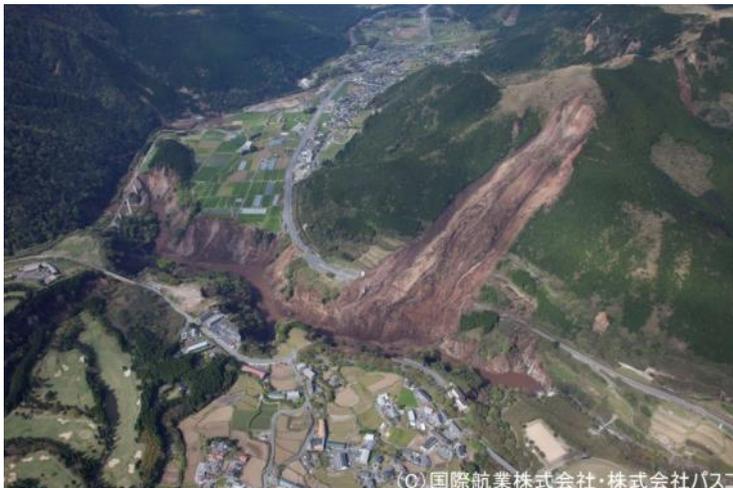
Figure 8 is the photo of steep slope collapse of near the somma just north of Futagawa Fault.

Fig. 8
Large collapse on the steep slope of near the somma of Volcano Aso (View from point A in the Fig. 7)

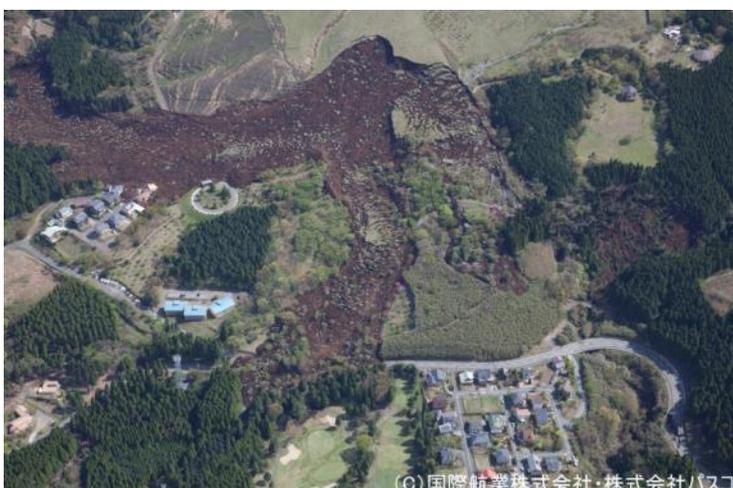
Landslide on gentle slope shown in Fig.9 would be slipped along very soft and high water content pumice layer of Quaternary tephra.

Fig. 9
Landslide flows on gentle slope of the lava dome. Landslide slip would have occurred in the tephra which covered on the lava.(View from point B in the Fig. 7)
