Brief report of the 2016 Kumamoto Earthquake in JAPAN

IAEG Japan National Group (Japan Society of Engineering Geology)

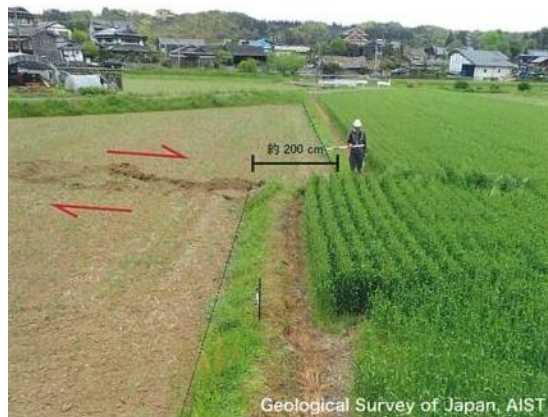
There are two right lateral active faults, Hinagu fault and Futagawa fault near Kumamoto City. According to the analysis of the surface movement by MAI (Multiple Aperture Interferometry), right slip movement along these faults are clearly shown. (Fig.5) And surface faults along Futagawa Fault with right lateral slip displacement of maximum 2 m were observed. (Fig.6)

Fig. 6 Earthquake surface fault along Futagawa Fault.
→ Right lateral slip movement was observed.
