Japan National Group

1) Investigation Team for Disaster Prevention

West Japan downfall disaster

Hokkaido, East Iburi Earthquake

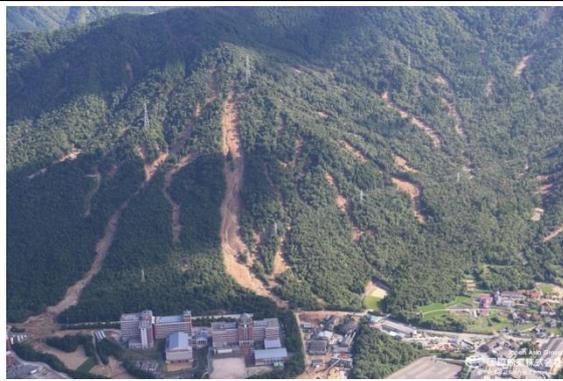
<p>Accumulated Rainfall (mm) from 2018-07-06 09:00 JST to 2018-07-07 09:00 JST</p>

Recently, we experience increasing number of extremely heavy hourly rain in Japan. The West Japan downfall disaster in July, 2018, was induced by maximum rainfall of 1,800mm in only four days in various areas of mainly western Japan. This extreme heavy rain in wide area was caused by many linear rainfall belts along the energetic seasonal rain front after a typhoon attack. Many debris flows and landslides, rapid floods occurred in many areas in a short period. Over 200 lives were lost.
