Brief report of the 2016 Kumamoto Earthquake in JAPAN

IAEG Japan National Group (Japan Society of Engineering Geology)

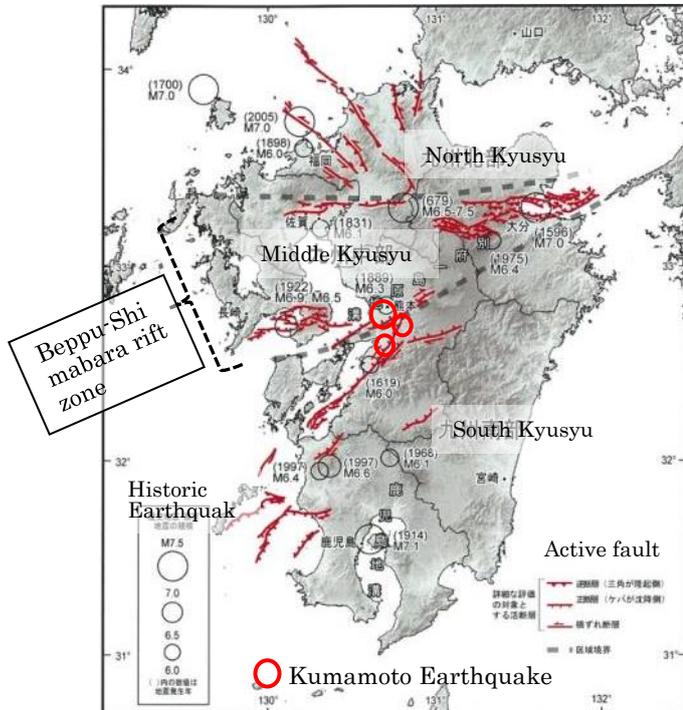
The Okinawa Trough which locates north of Ryukyu Arc has been expanding to south direction. The Beppu-Shimabara rift zone in the Middle Kyushu is considered to be part of this Okinawa Trough zone. Therefore tensional stress of north to south direction is dominant in the middle to south Kyushu area. (Fig.2 and Fig.3)

Fig.2 Active faults and historic Earthquakes in Kyushu
 Fig.2, 3 The Headquarters for Earthquake research Promotion, report in 2013
<http://www.jishin.go.jp/>

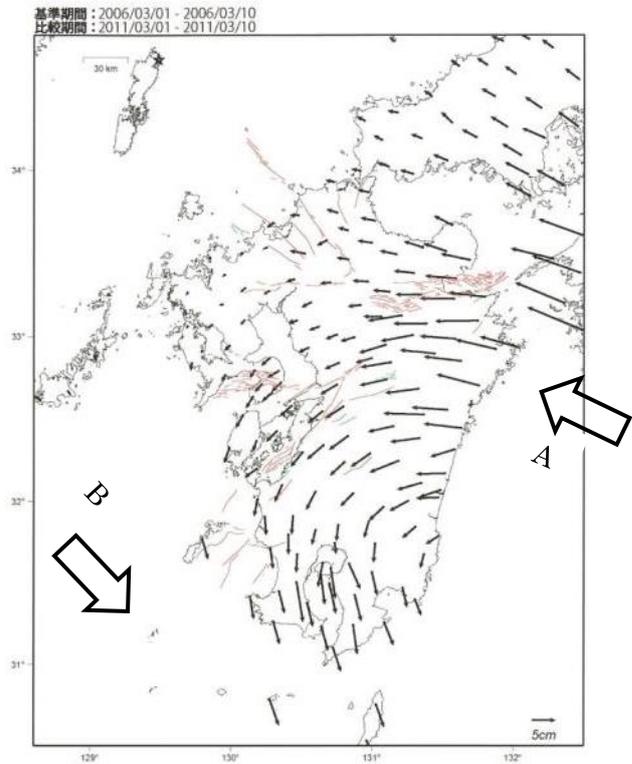
Fig.3 Average speed vector of displacement in the 5 years since March 2006
 A: Compressive stress caused by Philippine Plate
 B: Expanding of Okinawa Trough

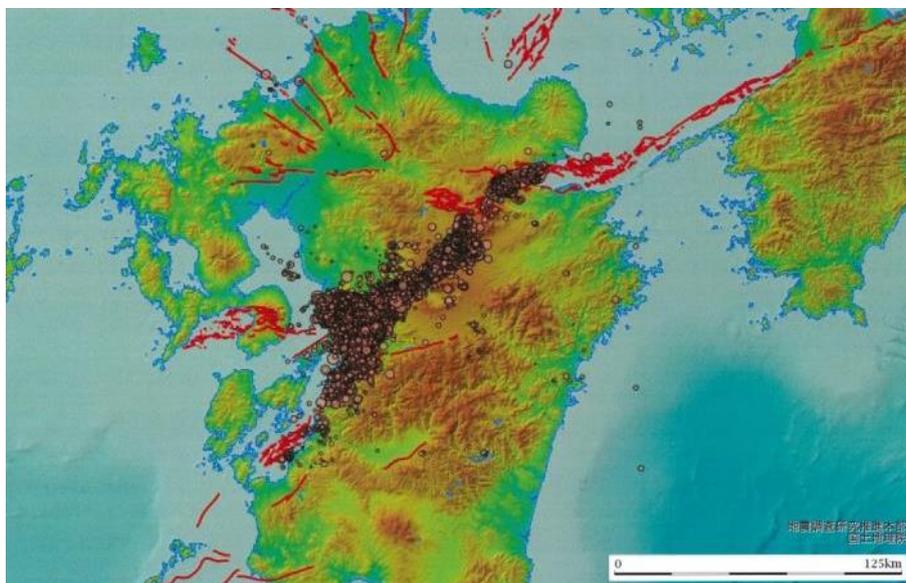
The epicenters of the Kumamoto earthquake and aftershocks since April 14 are distributed SW-NE direction along the southern edge of the Beppu-Shimabara rift zone. (Fig.4) It was reported that the type and the focal depth of main earthquakes were lateral slip type faults and about 10 km respectively.

Fig.4
 Distribution of the epicenters since April 14 2016
 (At May 10, 14:46)

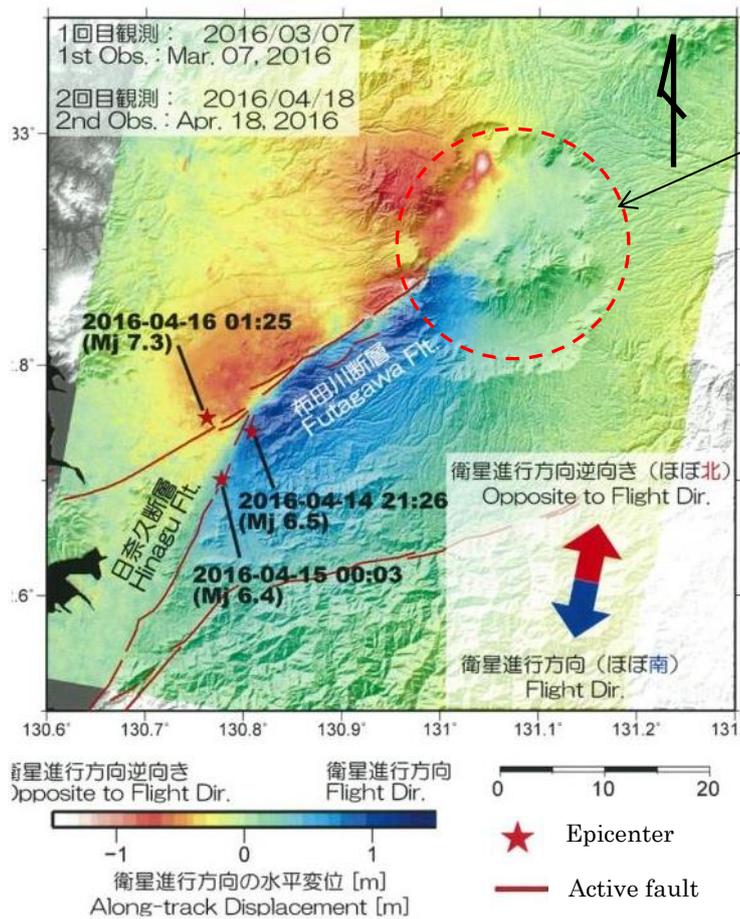
There are two right lateral active faults, Hinagu fault and Futagawa fault near Kumamoto City. According to the analysis of the surface movement by MAI (Multiple Aperture Interferometry), right slip movement along these faults are clearly shown. (Fig.5) And surface faults along Futagawa Fault with right lateral slip displacement of maximum 2 m were observed. (Fig.6)

Fig.5 MAI (Multiple Aperture Interferometry) analysis using ALOS-2/PALSAR-2
